Uncontrolled runaway and derailment of banking locomotives

Kankool, New South Wales, on 3 June 2020

ATSB Transport Safety Report
Rail Occurrence Investigation (Defined)
RO-2020-008
[Final – 1 February 2022]

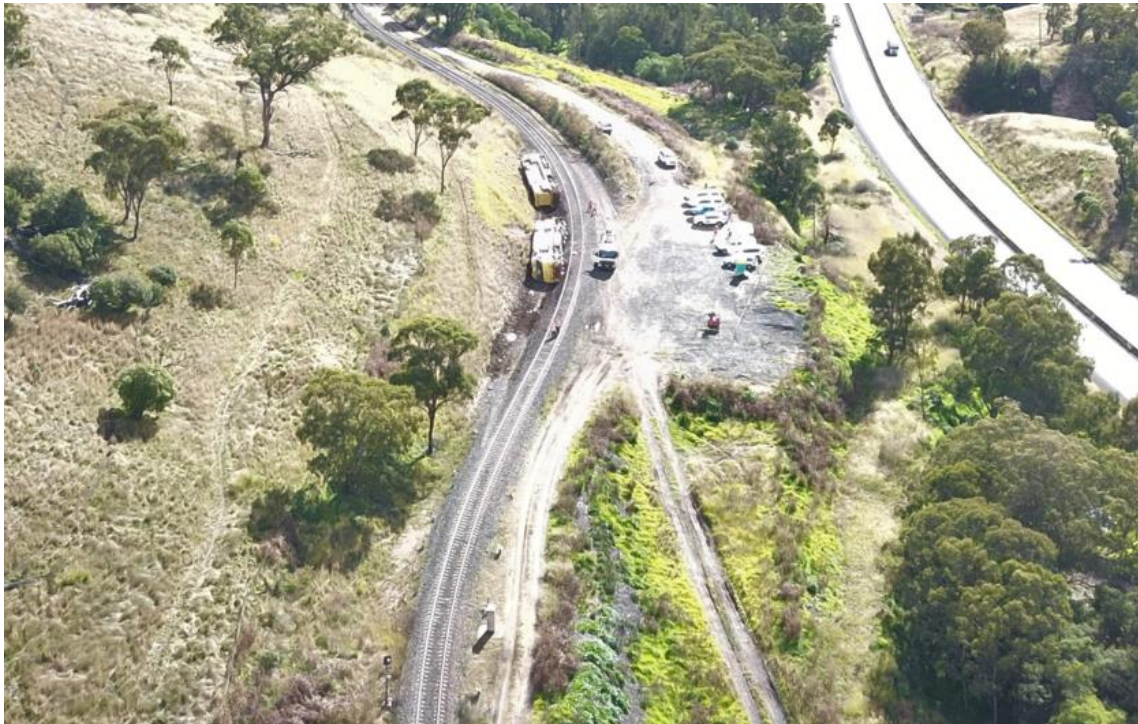
Cover photo: Aerial view of derailment site
Source: Aurizon

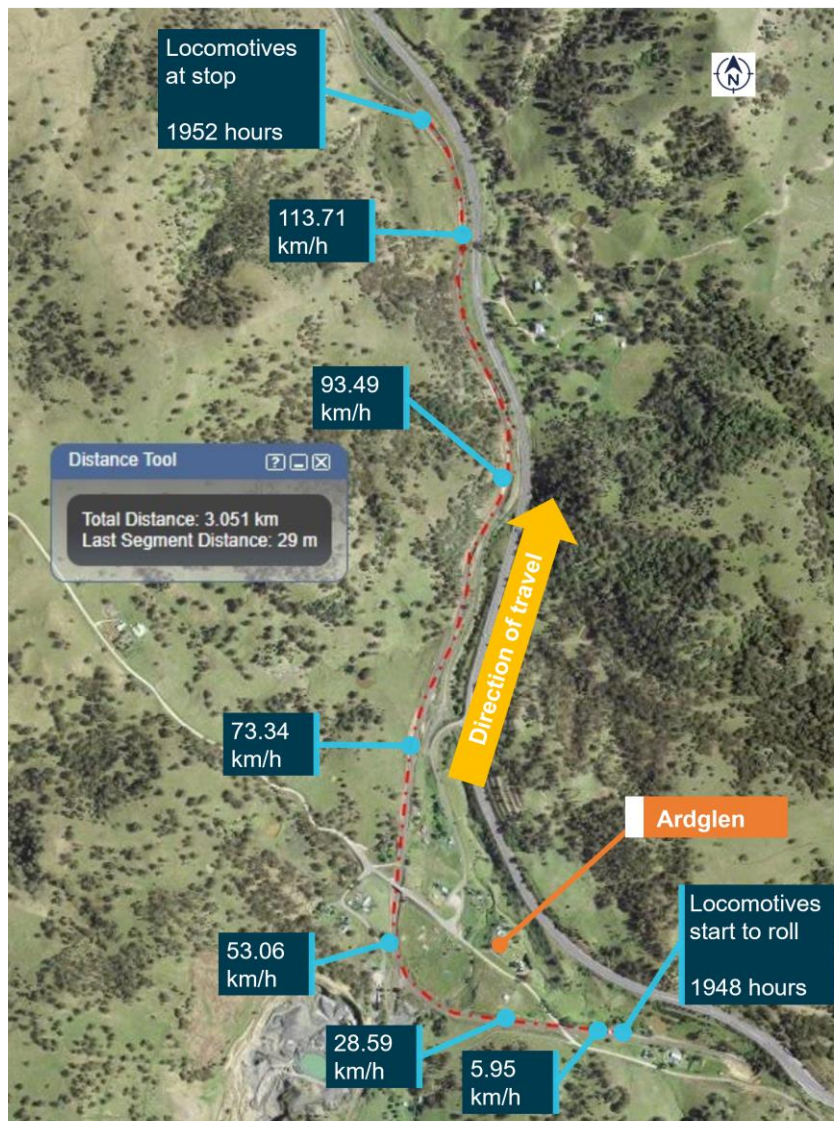
Figure 1: Runaway

This figure shows the path of the runaway and the speed of the locomotives as they progressed from Ardglan towards Kankool. Source: SIX maps and ARTC trip report, modified by OTSI

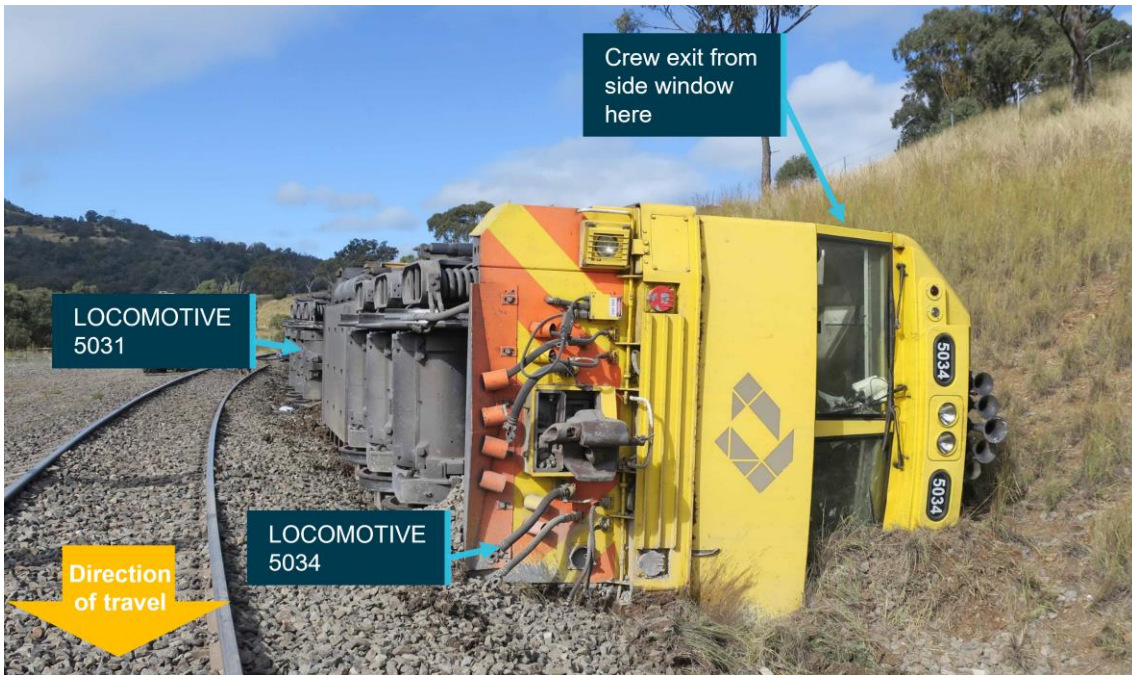
Figure 2: Derailed locomotives

The locomotives had derailed at 366.529 km by overturning to their left side and parting in the process, sliding along the ballast, before coming to rest approximately 13 m apart at 366.619 km.

Both locomotives sustained significant damage and approximately 100 m of rail track was damaged as a result of the derailment.

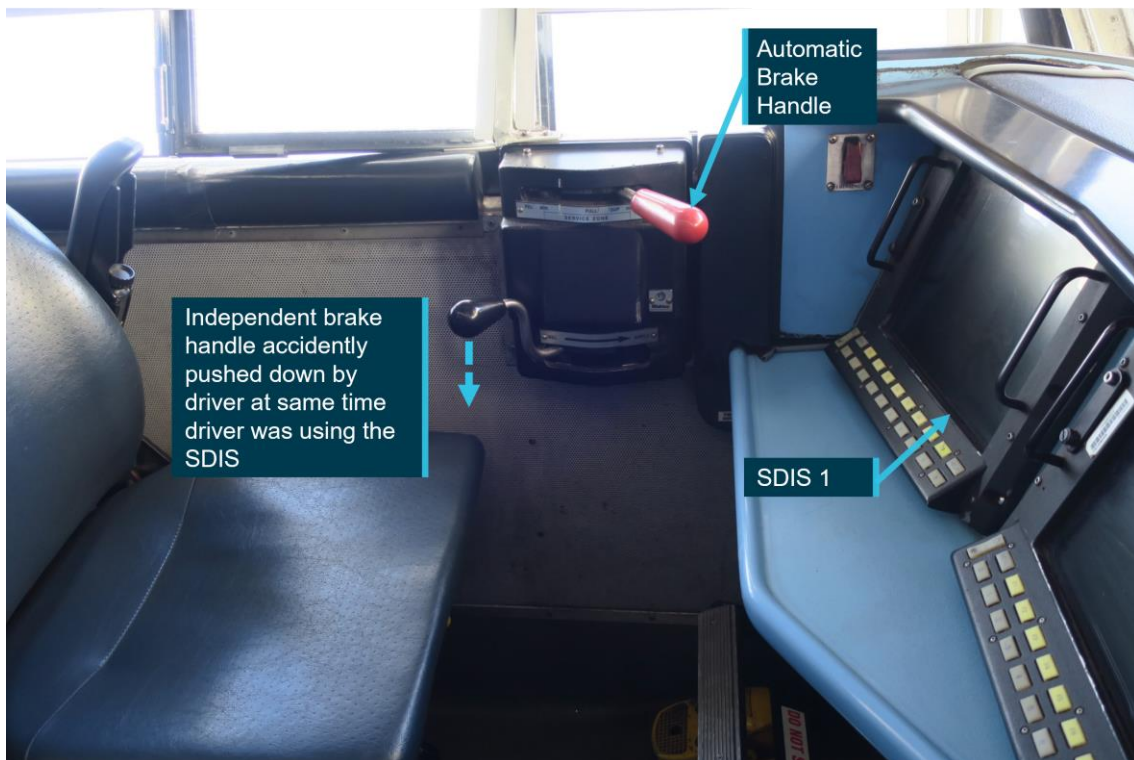
Figure 12: Independent brake handle and SDIS

Driver A was interacting with the SDIS to change the locomotive from Lead to Trail. As they leant forward to do this, driver A likely inadvertently depressed the independent brake handle (Figure 12) causing the brake cylinder to vent air to atmosphere. At 1947:45, when driver A placed locomotive 5031 into Trail Cut-out mode, they were unaware brake cylinder air had also started to vent and continued until the brake cylinder pressure reached 0kPa.

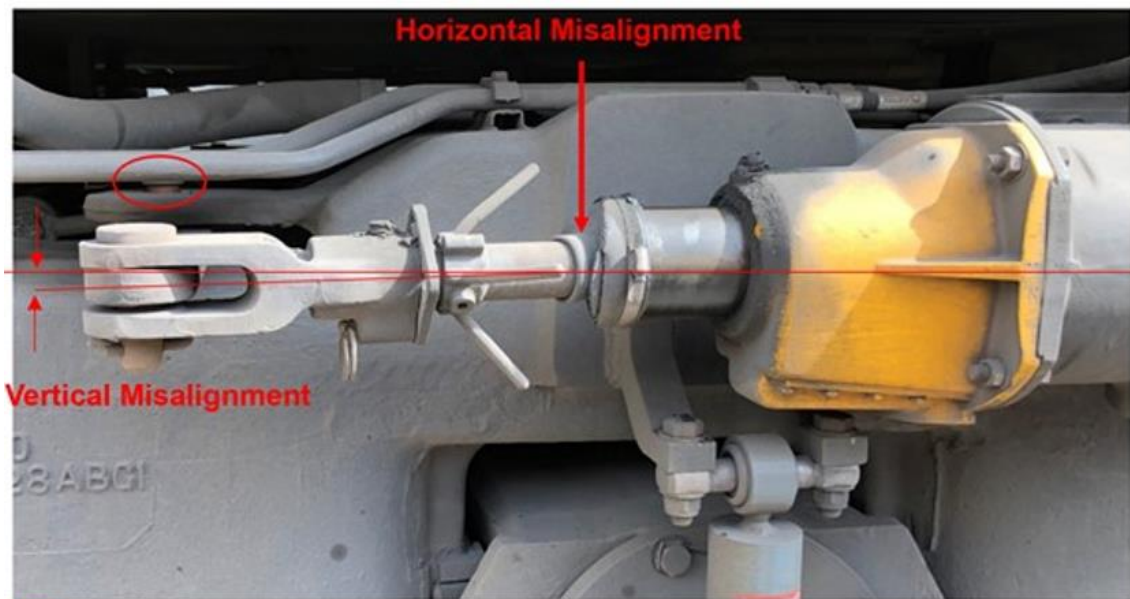
Figure 13: Brake cylinder connection to top lever

However, further investigation into the performance of the park brake system found previously undetected misalignment of the brake rigging on the vertical and horizontal planes and friction levels were contributing to a significant decrease in effective park brake force (Figure 13 and Figure 14).

This figure shows the misalignment of the top lever with the brake cylinder.
Source: Aurizon

The misalignment and friction in the brake rigging likely resulted in a reduced efficiency transfer of brake cylinder force, approximately 55 to 65 per cent efficiency. This resulted in a reduced force being applied at the interface of the brake pad and the wheel (brake shoe force).

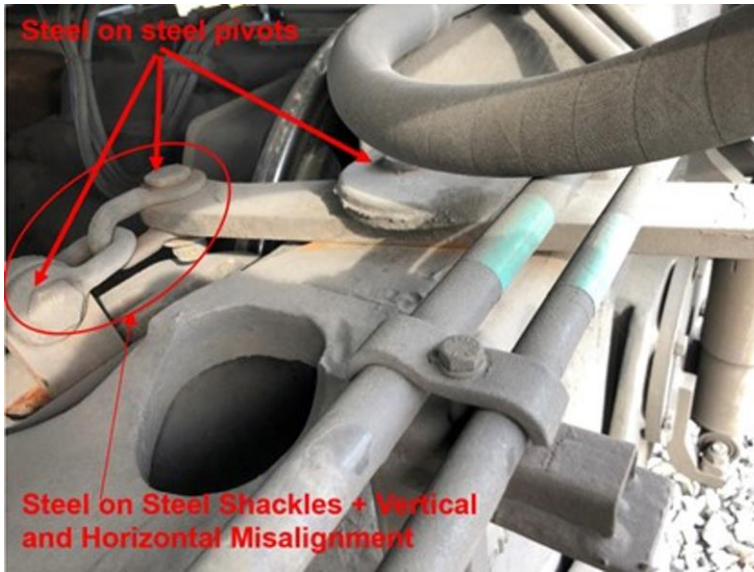
Figure 14: Pivot plate and shackle

The investigation into the performance of the park brake system found the locomotive park brake hold force was not effective on gradients steeper than 1:40.

*This figure shows points of friction and horizontal misalignment.
Source: Aurizon*

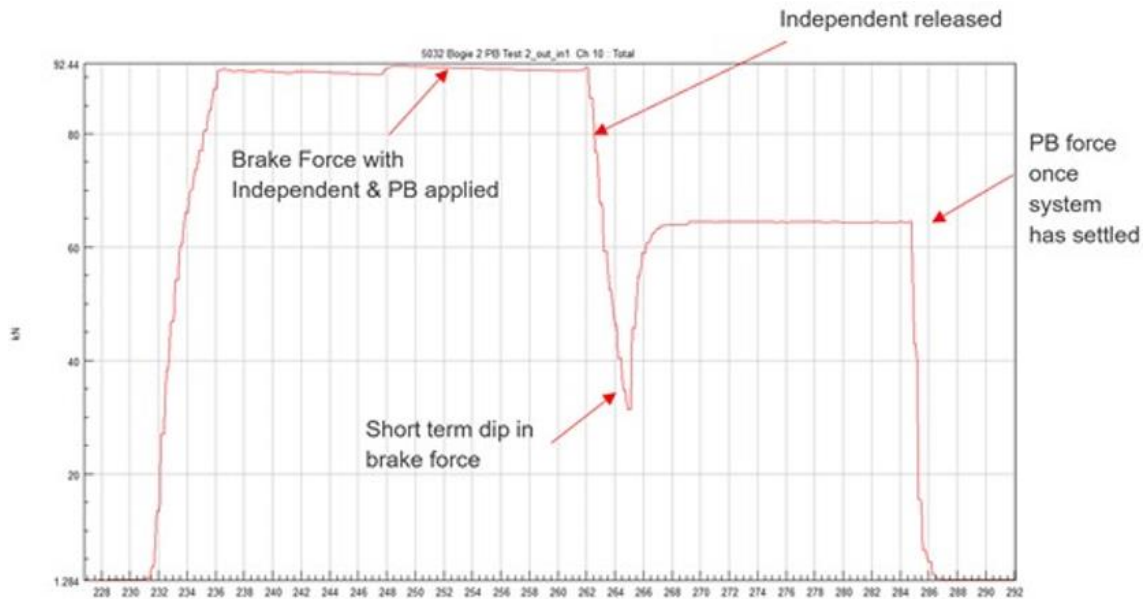
Figure 15: Brake shoe force over time

Operator testing after the incident showed that the brake shoe force dips below the applied park brake force when the independent brakes are released (Figure 15).

*This figure shows the brake shoe force over time with a transition of independent brake to the park brake.
Source: Aurizon*

It is likely this dip in brake force was caused by the arrangement and components used in the anti-compounding air brake mechanism. This acts to prevent excessive or compounded pressure being applied at the brake shoe and wheel interface. The brake force from the independent brake and the park brake applied together was greater (92.44kN) than when the park brake was applied alone. Additionally, when the independent brake was released, the resulting brake force dipped briefly before the park brake force settled at 65kN. It is most likely the locomotives started to roll when the resultant brake shoe force decreased during the brake force dip.

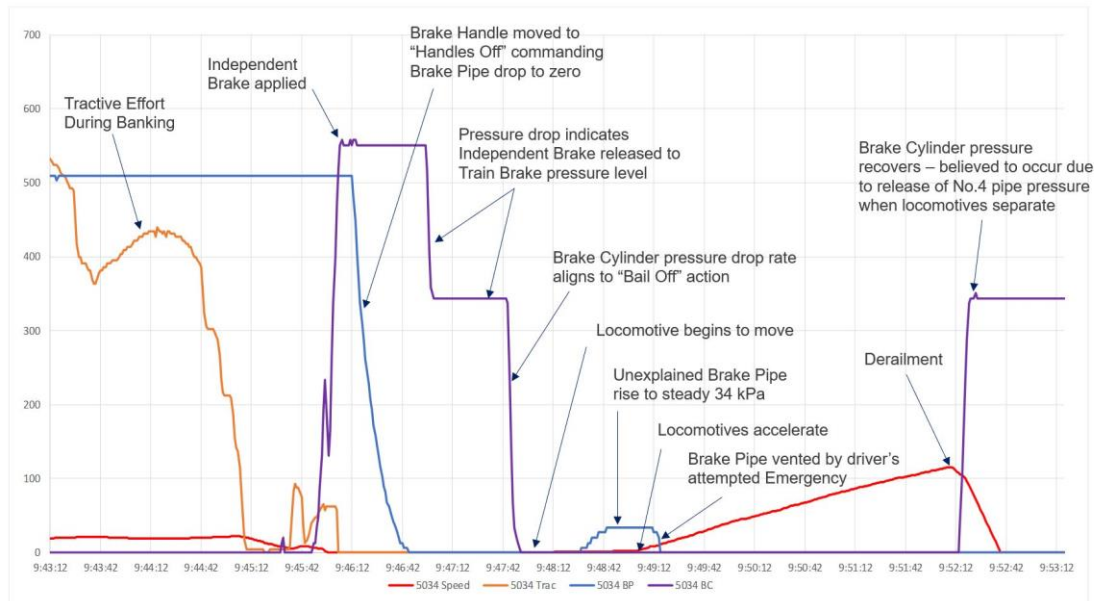
Figure 16: Analysed event recorder log

A few seconds later the automatic brake handle was placed into emergency, also to no effect in stopping the locomotives as the locomotive was still in Trail Cut-out mode. This application appears to have released a slight build-up of air in the brake pipe (see blue line in Figure 16). The cause of the slight build-up of air in the brake pipe (to 34 kPa) could not be determined. The brake pipe pressure did not increase again from 0 kPa after this first emergency application.

This figure provides an explanation of activities coinciding with recorded data on locomotive 5034.
Source: Aurizon
