Uncontrolled runaway and derailment of banking locomotives

Kankool, New South Wales, on 3 June 2020

ATSB Transport Safety Report
Rail Occurrence Investigation (Defined)
RO-2020-008
[Final – 1 February 2022]

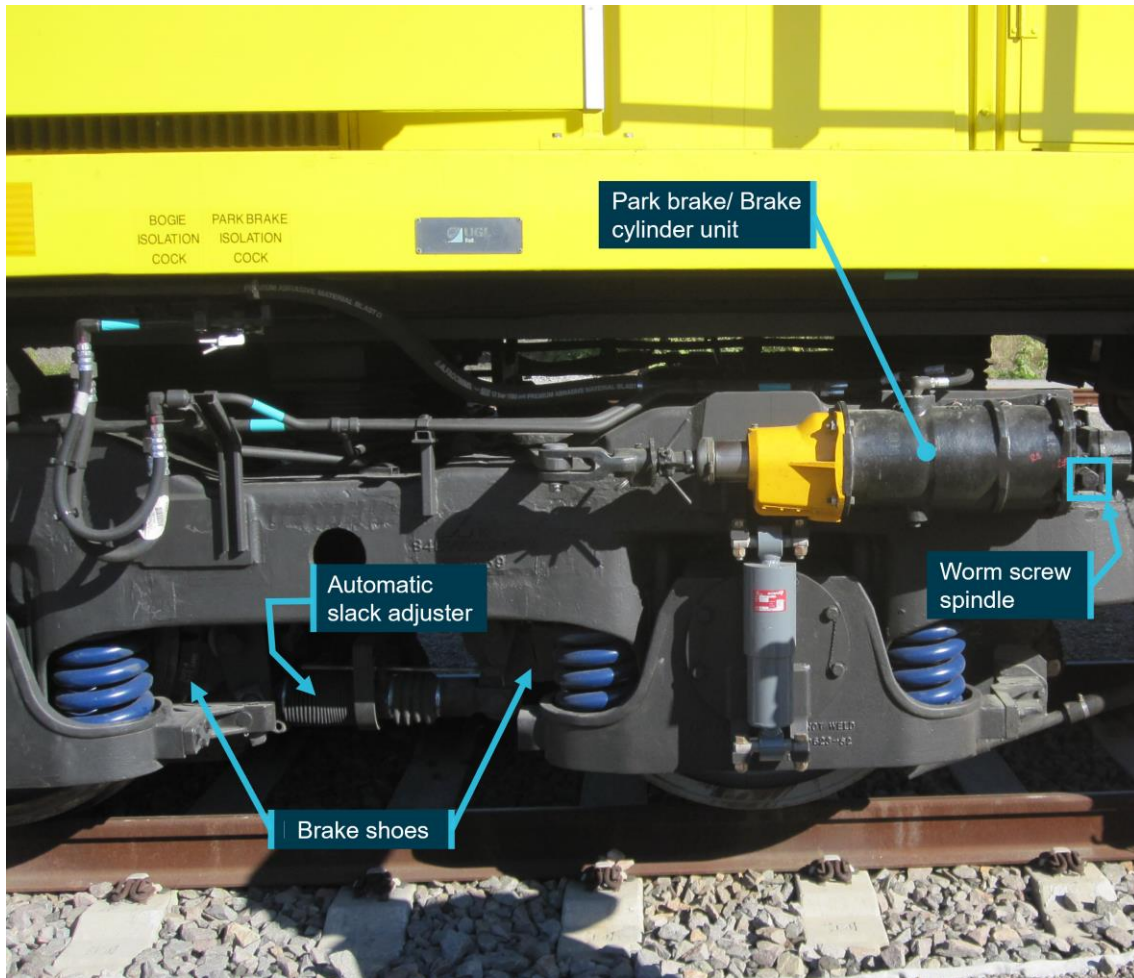
Figure 8: Park brake system

*This figure shows the park brake mechanism which is located on one of the bogies of a 5020 class locomotive.
Source: OTSI*

However, further investigation into the performance of the park brake system found previously undetected misalignment of the brake rigging on the vertical and horizontal planes and friction levels were contributing to a significant decrease in effective park brake force (Figure 13 and Figure 14).

The investigation into the performance of the park brake system found the locomotive park brake hold force was not effective on gradients steeper than 1:40.

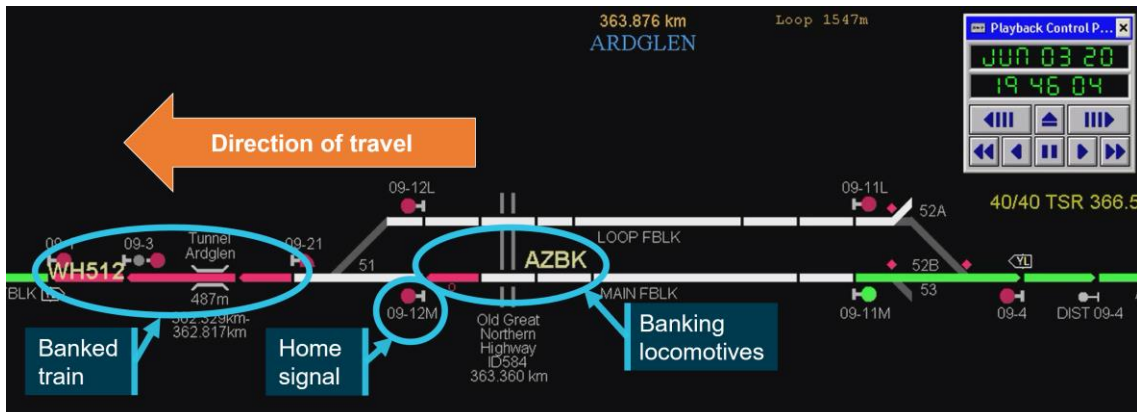
Figure 11: Phoenix display

This figure shows the separation of banked train (WH512) from the banking locomotives (AZBK) prior to reaching the Up home starting signal (09-12M) at Ardglen.
